# EVALUATION OF THE FIRST PLANK PERFORMANCE MEASUREMENTS

by A. A. BACKSTROM  
Aerophysics Department, Mississippi State College

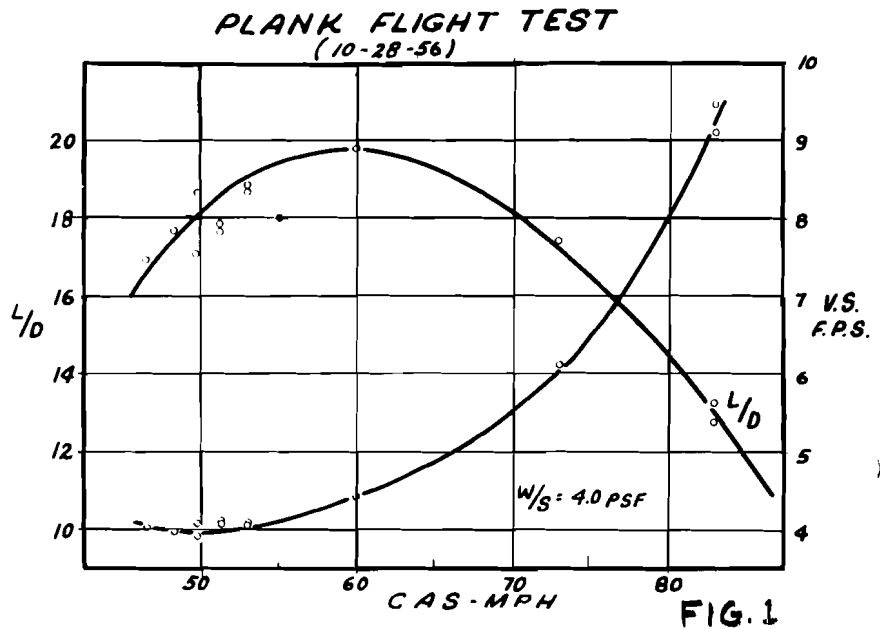
The rate of sink, and L/D vs air-speed curves (Fig. 1) reveal that although the ship was rather good in the mid-speed range, around 60 MPH, the performance fell off both above and below this range. The curve of  $C_L^2$  vs  $C_D$  (Fig. 2) was then plotted to analyze this behavior. From this curve it was seen that the actual airplane curve (solid line) was deviating from the theoretical curve (dotted line). The slope of  $C_L^2$  vs  $C_D$  is a function of span efficiency factor and from this it can be seen that the span efficiency is being reduced in the low speed, high  $C_L$  range. Also it should be noted that the drag is increasing in the high speed range. The average span efficiency factor is also seen to be 75% which is much lower than that which can be anticipated with a clean wing fuselage intersection. Also the maximum lift coefficient

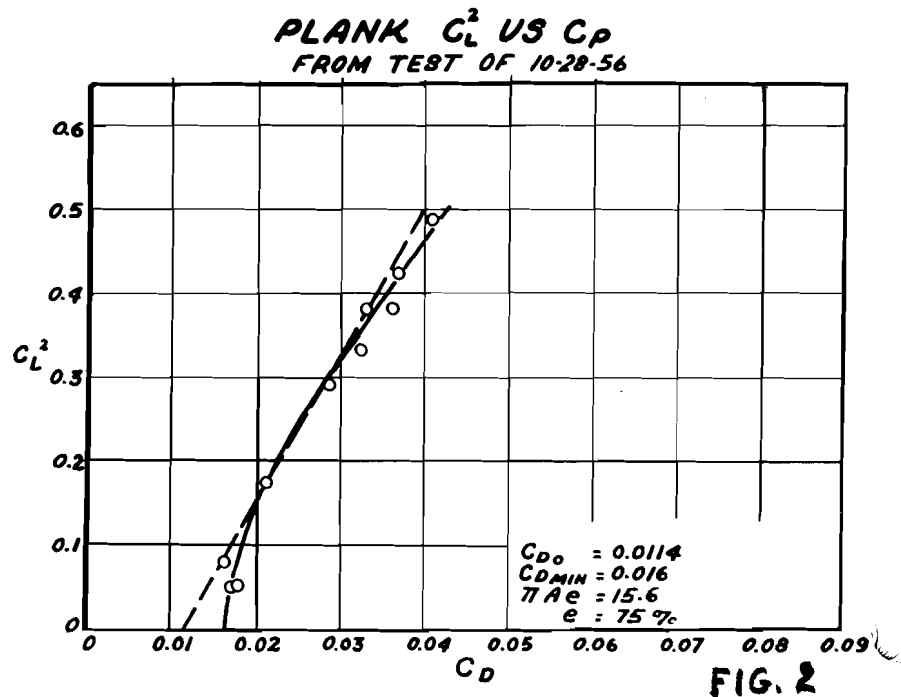
was found to be 0.75 when it should have been approximately 1.0. These factors point out that there are several things wrong but give no indication as to what.
