Lloyd Licher's Gold badge distance flight of July 9, 1961. The flight began at El Mirage and ended at a road junction near Yucca, Arizona.

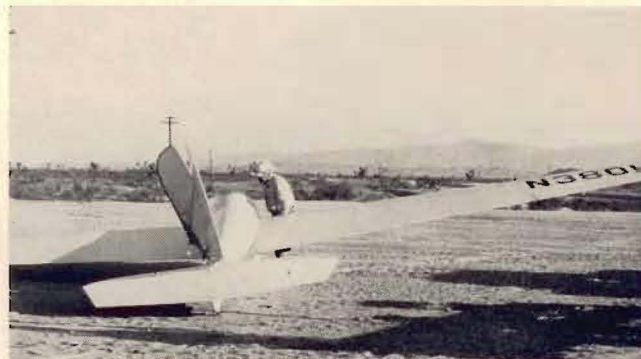
I had hit unseen power lines across the road between poles set far back. They had not broken but evidently shorted out a circuit breaker somewhere because the whole town was without power. What a grand, but inglorious entrance! By coincidence I had landed in front of the only house in town with a private phone but it was dead because of the power failure. The one pay phone in town was knocked out too, but it went on battery operation and was usable—barely. The power company was notified and service was resumed an hour later. Pete arrived less than a half hour after the 6:05 landing so we were loaded and headed home by 8:00 PM. It was 118 degrees there that day and most of the way along Highway 66. Pete really deserved special recognition for such a hot retrieve.

The power line first contacted the ship about a foot in front of the canopy, wiped off the yaw string post there, swept up over the canopy, scratching it a bit, clipped off an unused antenna mount on the aft hatch and next hit the fin. The fin was knocked back to a 45-degree swept angle. The front attach bolt failed in tension, allowing the spar to bend back. Not repairable. The bottom of the rudder crumpled on the stabilizer. Repairable. Their combined deflection to one side evidently caused the ground loop. There were a few minute burn marks on the top of the right wing where the power lines had swept over the metal surface. It's a good thing I wasn't one foot higher or the story might have had a different ending.

The world's first swept-tail 1-26, the result of some last-minute in-flight modifications made while landing near Yucca.

We arrived home from the retrieve at 3:30 AM with 685 miles on the car that day, for which the gas cost \$15.33. The tow cost \$3.00 and a new fin kit was \$38.50 plus air freight. Repairs were completed in time for participation in my only Nationals, a cherished experience. The 199.5 miles for the flight set a mark which was not beaten in the Schweizer Best Flight Contest for the West Coast states so I won a barograph for my effort, as well as the goal Diamond and Gold distance. I'm sure that Diamond distance was possible that day, even in a 1-26, if oxygen were used to permit a higher working range and better speed flying techniques were used. At any rate, I had made my Big Flight with relative ease and could henceforth hold up my end of future hanger-flying sessions as one with a significant experience to relate.
