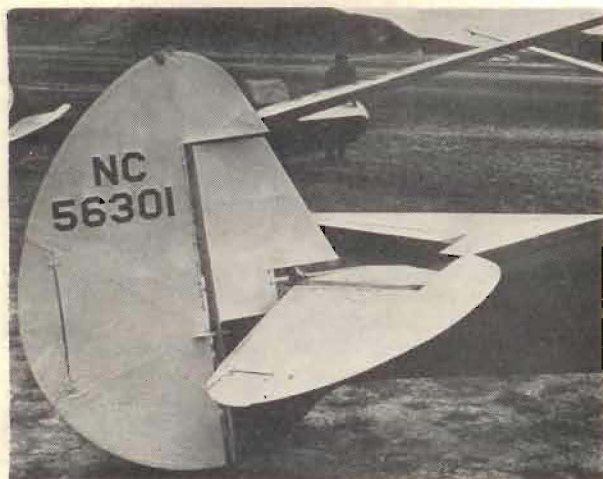
**BEFORE.** A standard LK empennage, showing balance surfaces, and drag producing gaps.

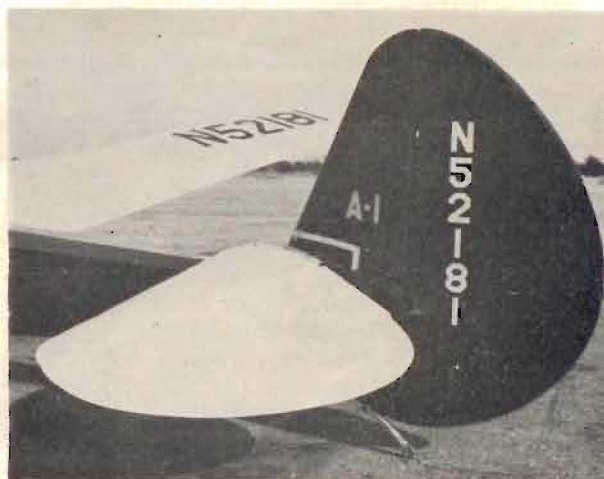
**and AFTER.** Flat Top tail group, with balanced surfaces moved and gaps closed.

An additional change in the controls on the TG-4a appeared warranted after some flying with the standard job. Since the rudder forces were found to be quite small, the aerodynamic balance was removed and attached to the fin. This change does not increase the rudder control forces so that one has to stand on the rudder, but it does give a "feel" to the rudder.
