FLIGHT CHARACTERISTICS OF THE PHOENIX SAILPLANE

by AUGUST RASPET

(Editor's note: This is a letter written by the author to his sailplanist son, David.)

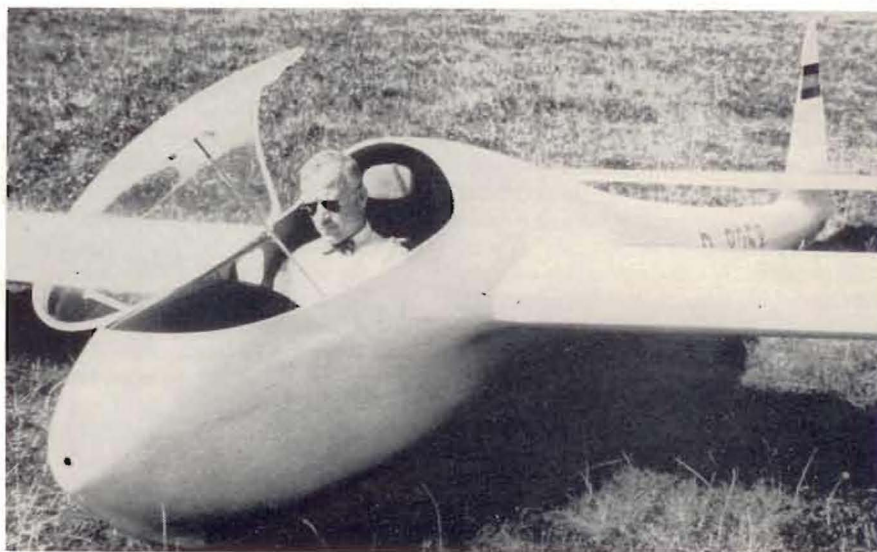
Raspet just prior to take-off. Note adjustable head rest and smooth wing fillets.

First, the cockpit is beautifully laid out. The reclining position is used but with an adjustable head rest. A side release near the skid, good for winch as well as airplane tow, is used. For the towplane we used a Klemm 107 with an 150 HP Lycoming engine. The acceleration was rather poor and made the skid take-off on the rough field rather shaky. Not that I minded it but every shock I felt for Phoenix.
