SAFETY FIRST

THE GRAY HAIR DEPARTMENT

by JOSEPH M. ROBERTSON, *Chairman*
SSA Safety and Flight Operations Committee

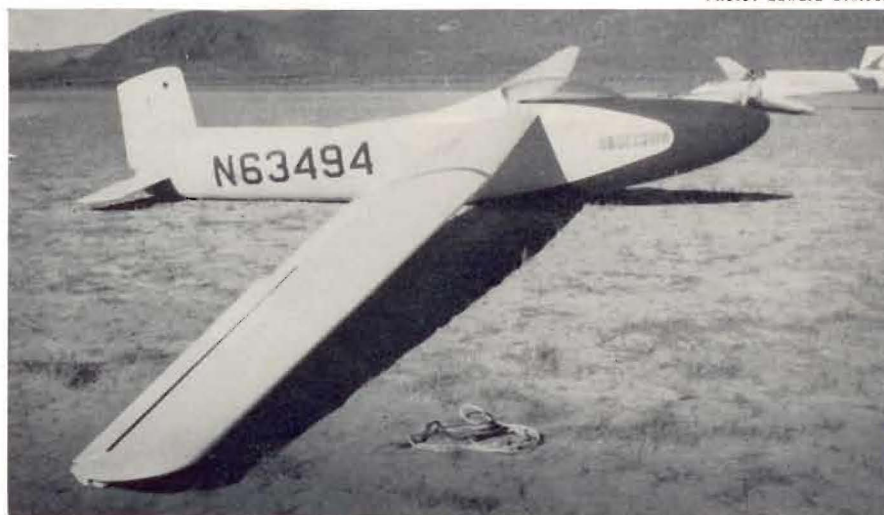
Photo: Edward Blalock

Ed Blalock's Nimbus IIIB sailplane "Obsession" built by him in Reno, Nevada. In background is the Napa, (Calif.) Soaring Club's Schweizer TG-3A.
