THE OLYMPIA EON

A Sailplane Catalogue Item

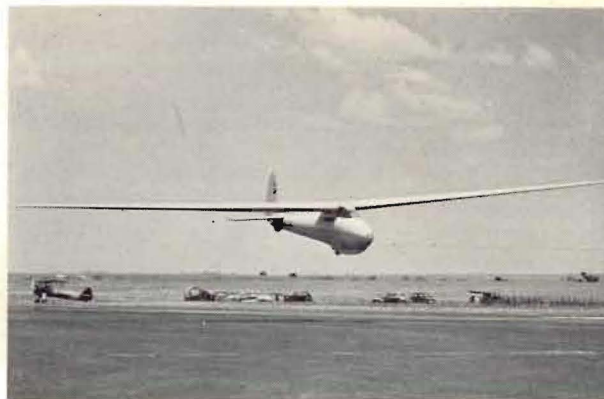
This is the basic sailplane which was entered in the design competition against the Orlik, Mu 17 and several others. It was designed as the sailplane which would be used in the Olympic Sailplane Competition in 1940. Jacobs, the designer of the Buzzard, Weihe and Reiher laid out this design as the D. F. S. Meise. Following the World War II, it was redesigned to British C. of A. requirements. In doing this, the ship picked up over 80 pounds.

The outstanding feature of this Olympic design is its beautiful handling at all speeds.

Span	49.3
Length (Overall)	23.9
Height (Overall)	5.23
Fuselage Width (Overall)	1.97
Fuselage Ht. (Overall)	2.95

Wing Platform	Tapered
Sweepback	0° at 25% C
Dihedral	2.5°
Gull	None
Root Chord	4.76 ft.
Half Span Chord	3.28
Tip Chord	1.81 ft.
Aspect Ratio	15
Taper Ratio	2.64
Load Factor	9.6
