## HOW-TO-DO-IT

# LEADING EDGE REJUVENATION FOR OLD SAILPLANES

by ALDEN G. WILSON

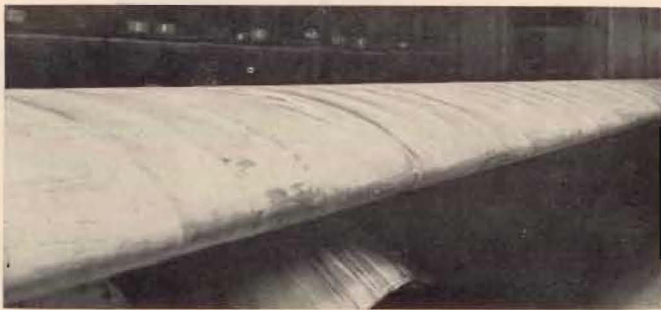
Photo No. 1. Sharp cross-lighting emphasizes the "Sag" in the leading edge plywood between ribs prior to removal of fabric.

An unfortunate characteristic of wooden sailplanes, especially European designs, is the tendency of the plywood around the wing leading edge D-tube to sag a bit between the ribs. This doesn't happen to as great an extent on such American WW-II surplus types as the L-K and TG-3 because the plywood skins are heavier. The sag between the ribs, noticeable in Photo No. 1, which was taken with careful cross-lighting, does not indicate structural deterioration or even decreased torsional strength of the D-tube. Even brand-new ships show evidence of it. It is caused by the tendency of the glue to pull the skin down at the sides of the rib due to glue shrinkage.

thing is to fill in the low points and build the whole leading edge up to a smooth continuous surface again. In the past, this has been done with various commercial putties and home-brew mixes, but their principal disadvantage has been that they become brittle when dry and crack under the flexing of the wing. The new epoxies, however, remain flexible, and after a year and a half of testing on Pete Bowners' old Weihe, seem to be the perfect answer to the problem.

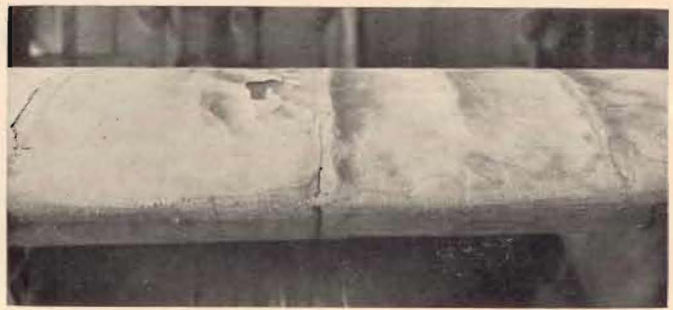
Photo No. 2. At the left, old and cracked solid filler material still in place. At the right, the filler removed and the wood surface sanded and ready for new filler.

The first step in the rejuvenation was to remove the old cracked putty. Approximately nine pounds of it were sanded off of the 60-foot Weihe wing. Photo No. 2 shows cleaned areas and the old cracked filler in

adjacent sections. Be very careful in the sanding operation not to sand away any plywood.

The original putty was removed and the wood cleaned with a wire brush and sandpaper to insure a clean bonding surface for the epoxy

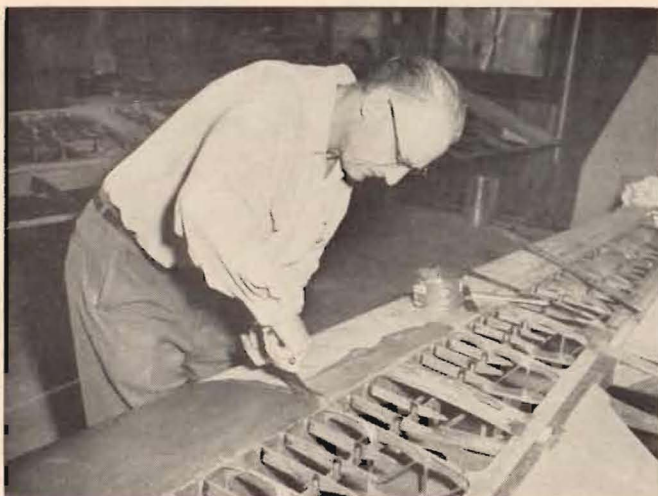
Photo No. 3. Al Wilson applying Epoxy/Microballoons mix with spatula. Area at lower left of photo has already been filled and smoothed.

The new filler is made up of TRECO 520 Grade 2 Epoxy Resin "AB" and "CD" mixed to proper consistency by adding microballoons, which are very tiny plastic balls, actually hardened bubbles. One pound of microballoons just fills a one-gallon paint can. Each of the two mixes has a different specific gravity, so a set of scales is required for mixing by weight. All of the necessary ingredients, including separate "AB" and "CD" mixtures already made up, are available from Technical Research Co., 13535 Monster Road, Seattle, Wash. The Weihe wing, larger than the average sailplane wing and an example of an extreme case of sag, required five pounds of each mix and nearly one and one-half pounds of microballoons for the full treatment on both sides.

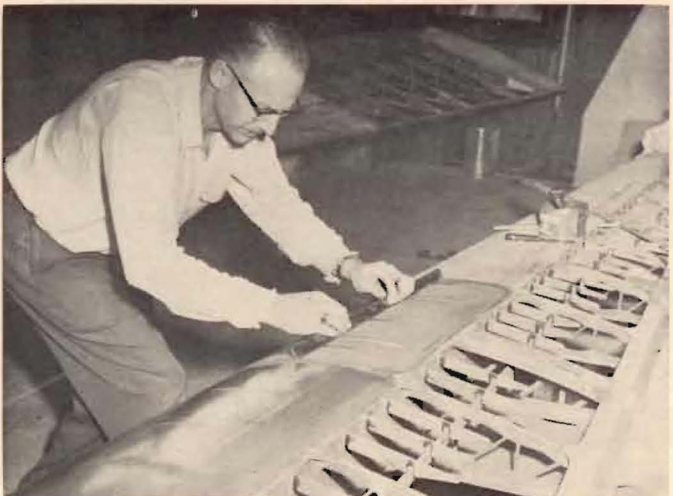
Photo No. 4. Smoothing the mix with a straightedge. Note how the filler is scraped completely off the high points at the ribs.
